MASSACHUSETTS HISTORICAL COMMISSION FORM B - BUILDING

Town Provincetown
Place (neighborhood or village)
Address 26 TREMONT ST
Building ID 778
Parcel No. (PID) 06-2-056-0
Mapbase # 06-2-056
Building Area 842.29
Historic Name
Present Use Residential - Multi-unit
Original Use Residential
Date of Construction 1850-1870
Source NR Nomination
Style/Form Greek Revival
Architect/Builder
Exterior Material wood shingle
Foundation brick
Wall/Trim wood
Roof Side gable
Outbuildings/Secondary Structures

Recorded by Johnette Davies
Organization Kise Straw & Kolodner
Date (month/year) April 2004
Form Status new update

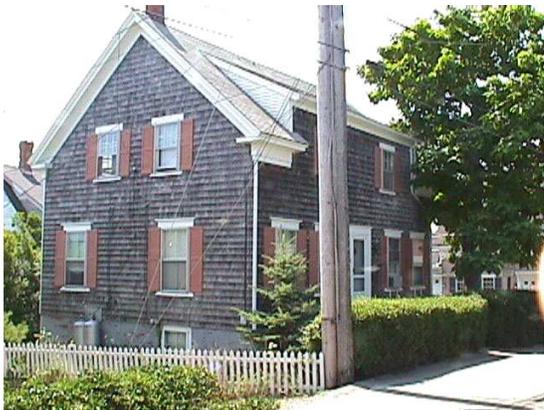
Photograph

26 Tremont Street is a 2-story, 5-bay center entry building. The side-gable roof has interior end brick chimneys at each end, partial cornice returns at the gable ends, and a frieze below the eaves. Shed-roof wall dormers across most of the primary and rear facades provide the 2nd full story. The main entry is a panel door with storm, accessed by a concrete block and brick stoop. Windows are wood 2/2 and 6/1 wood DHS. 2/1 DHS are located at the basement level. An exterior stair at the rear and deck around the side provide access to secondary entries at the rear 1st story and west side 2nd story.
