MASSACHUSETTS HISTORICAL COMMISSION FORM B - BUILDING

Town Provincetown
Place (*neighborhood or village*)
Address 11 CENTRAL ST
Building ID 87
Parcel No. (PID) 07-2-104-0
Mapbase # 07-2-104
Building Area 1439.785
Historic Name
Present Use Residential
Original Use Residential
Date of Construction 1830-1850
Source NR Nomination
Style/Form Greek Revival
Architect/Builder
Exterior Material wood shingle
Foundation stuccoed
Wall/Trim wood
Roof Front gable
Outbuildings/Secondary Structures
 1 garage; attached cottage

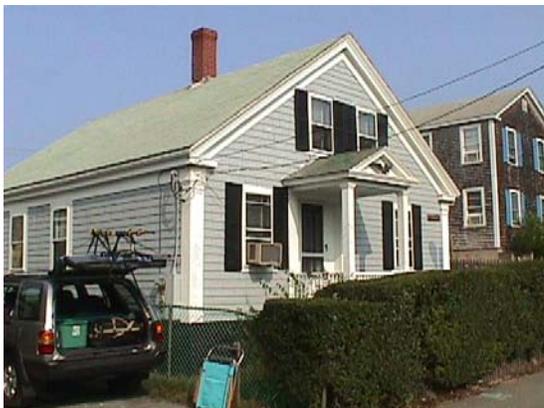
Photograph

Entry and window sash (20th cent.)

Condition Good
Moved no yes **Date**
Acreage 0.088
Setting

11 Central Street is a 1 1/2-story, 3-bay center entry, Greek Revival-style cottage. The building is clad in wood shingles, with staggered shingles at the cornice at the north and south facades. The front gable roof is clad in asphalt shingles; partial returns; interior brick chimney at peak. Corner pilasters present. The main entry consists of a pane and panel wood door with modern storm; raised entrance; brick deck and steps accessed from the south side; door under pedimented entry porch supported by square posts; simple balustrade. Fenestration includes 1/1 DHS wood with storms; inoperable shutters. A 1-story gable roof addition with brick interior chimney extends from the east gable end. This addition connects to a gable cottage, which is 1 story with a cross gable roof.
