MASSACHUSETTS HISTORICAL COMMISSION FORM B - BUILDING

Town Provincetown
Place (neighborhood or village)
Address 10 PEARL ST
Building ID 44
Parcel No. (PID) 12-1-100-0
Mapbase # 12-1-100
Building Area 1044.477
Historic Name
Present Use Residential - Multi-unit
Original Use Residential
Date of Construction 1850
Source Tax assessment
Style/Form Italianate
Architect/Builder
Exterior Material wood shingle
Foundation brick
Wall/Trim wood
Roof Front gable
Outbuildings/Secondary Structures
 1 cottage

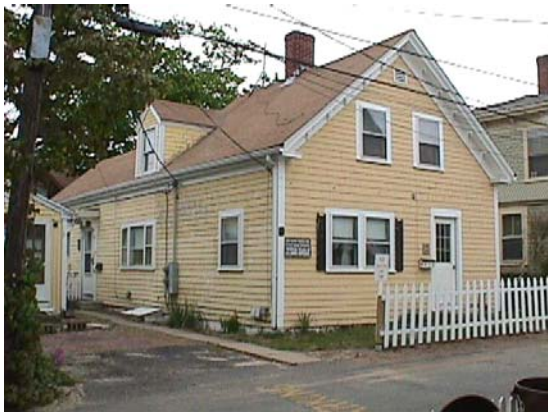
sash and entry altered (1970s); replacement fenestration.

10 Pearl St. is a 1 1/2-story, 2-bay sidehall cottage. The front-gable roof has partial returns; pendant brackets below the eaves; brick chimney at roof ridge; gable dormer in south roof slope. Main entry consists of a replacement door with simple wood surround; concrete stoop. Secondary entrance on south facade with flat hood and pendant end brackets. Fenestration includes 1/1 wood DHS replacements; 1 Chicago-style picture window present on south facade. 1-story rear ell with shed dormer on north roof slope.
