MASSACHUSETTS HISTORICAL COMMISSION FORM B - BUILDING

Town Provincetown
Place (neighborhood or village)
Address 3 CARVER CT
Building ID 907
Parcel No. (PID) 07-2-165-A
Mapbase # 07-2-165-A
Building Area 1325.274
Historic Name
Present Use Residential
Original Use Residential
Date of Construction 1820-1840
Source NR Nomination
Style/Form Astylistic
Architect/Builder
Exterior Material vinyl
Foundation brick/concrete block
Wall/Trim vinyl
Roof side gable
Outbuildings/Secondary Structures

Recorded by Vanessa Zeoli
Organization Kise Straw & Kolodner
Date (month/year) April 2004
Form Status new update

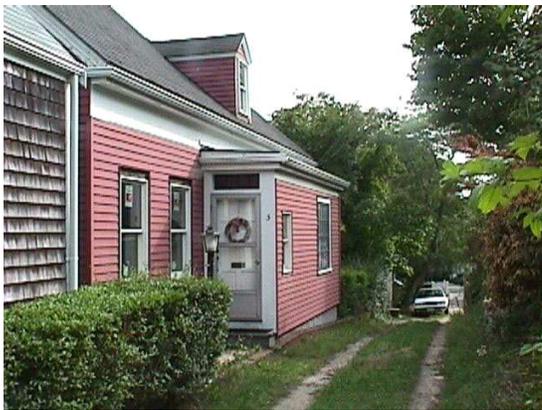
Photograph

3 Carver Court is a 1 1/2-story, 6-bay building with an addition. The side gable roof is clad in asphalt shingles; partial returns; eaves boxed in vinyl; interior brick chimney at roof ridge. The primary entrance is located on the east facade of an enclosed porch and contains wood panel door, window screen and historic 4-pane transom. The enclosed porch has a hipped roof; 24-pane wood picture window and 1/1 vinyl window. Other fenestration includes 1/1 vinyl DHS; 3/3 wood DHS in basement. A 1-story hipped roof addition is located on the west facade; concrete block basement; interior brick chimney with arched cap.
