MASSACHUSETTS HISTORICAL COMMISSION FORM B - BUILDING

Town Provincetown
Place (neighborhood or village)
Address 3 CARVER ST
Building ID 908
Parcel No. (PID) 11-1-013-0
Mapbase # 11-1-013
Building Area 1909.411
Historic Name
Present Use Residential
Original Use Residential
Date of Construction 1850
Source Tax assessment
Style/Form Queen Anne
Architect/Builder
Exterior Material clapboard
Foundation brick
Wall/Trim wood
Roof front gable
Outbuildings/Secondary Structures

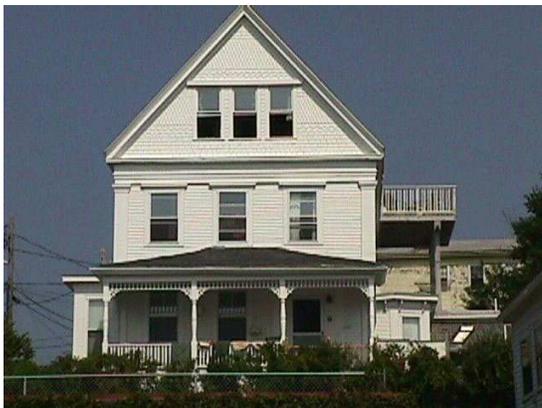
3 Carver Street is a 2-story, 3-bay sidehall dwelling clad in clapboard with staggered and diamond-shaped shingles in the gable end. Wood shingles clad the north elevation. The front-gable roof is clad in asphalt shingles; full return; interior brick chimney. Greek Revival-style corner pilasters present. A full-width, 1-story porch with flat roof, turned posts and spindlework; square balustrade; area beneath porch deck clad with shiplap siding boards; The main entry is a panel wood door with modern screen, door has entablature surround. Fenestration includes 2/1 wood DHS on front facade, 1/1 vinyl DHS elsewhere; triple windows in gable; wood surrounds. A rear 2-story section contains a secondary entrance on the west façade - pane and panel wood door with shallow flat hood over door. Square bay on west side near front with flat roof and dentil around eave. 2nd and 3rd-story porches present on east facade.
