# MASSACHUSETTS HISTORICAL COMMISSION

## FORM B - BUILDING

**Town** Provincetown  
**Place** (neighborhood or village)  
**Address** 7 ARCH ST  
**Building ID** 1699  
**Parcel No. (PID)** 12-1-107-0  
**Mapbase #** 12-1-107  
**Building Area** 630.184  
**Historic Name**  
**Present Use** Residential  
**Original Use** Residential  
**Date of Construction** 1875  
**Source** NR Nomination  
**Style/Form** Astylistic  
**Architect/Builder**  
**Exterior Material** shingles  
**Foundation** brick  
**Wall/Trim** wood  
**Roof** front gable/asphalt  
**Outbuildings/Secondary Structures**

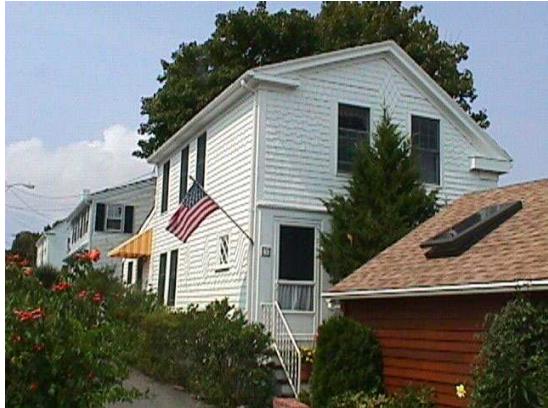
This building is a 2-story, 3-bay dwelling, facing south. The front-gable roof is clad in asphalt shingles with partial returns; exterior end chimney at the north gable end. The western roof slope was raised to accommodate a full second story on this side of the building, creating a shallow roof slope on this side. The building is clad in wood shingles, with bands of staggered and diamond shape shingles. The main entry contains a pane and panel wood door with wood storm and wood surround accessed by concrete block and brick steps. Fenestration includes 2/1 wood DHS on front façade; 6/1 vinyl DHS; diamond pane wood casement. A 1-story shed-roof addition at the north end has a brick foundation, secondary entrance (which may now be used as the primary entrance) containing a pane and panel wood historic door with wood storm; modern flat hood supported by brackets shades the door.
