MASSACHUSETTS HISTORICAL COMMISSION FORM B - BUILDING

Town Provincetown
Place (*neighborhood or village*)
Address 11 JOHNSON ST
Building ID 95
Parcel No. (PID) 12-1-109-0
Mapbase # 12-1-109
Building Area 1544.096
Historic Name
Present Use Residential
Original Use Residential
Date of Construction 1875
Source NR Nomination
Style/Form Italianate
Architect/Builder
Exterior Material clapboard
Foundation brick
Wall/Trim wood
Roof front gable
Outbuildings/Secondary Structures

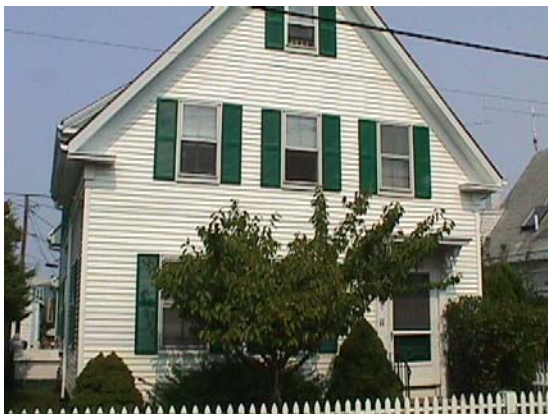
Photograph

cladding changed (1970)

Condition Good
Moved no yes **Date**
Acreage 0.087
Setting

11 Johnson Street is a 2-story, 3-bay sidehall dwelling. The front gable roof is clad in wood shingles; partial returns; gable wall dormer on south facade; frieze below eaves; shed dormer on north roof slope with partial returns; interior brick chimney at peak. Corner boards present. The main entry consists of a pane and panel wood door with modern storm; flat hood with brackets; accessed by brick steps and simple wrought iron hand rail. A secondary entrance at southeast with wood steps and flat block over door. Fenestration includes 2/2 wood DHS with entablature lintels; stained glass awning windows on south facade. A bay on the south facade has a flat hood, brackets under eaves, and scalloped trim.
